# Manhole Inspection Summary

Manhole # S39S\_\_044MH

Insp Date: **10/17/08 11:45 AM**

**Location** Address: **1414 key hw**

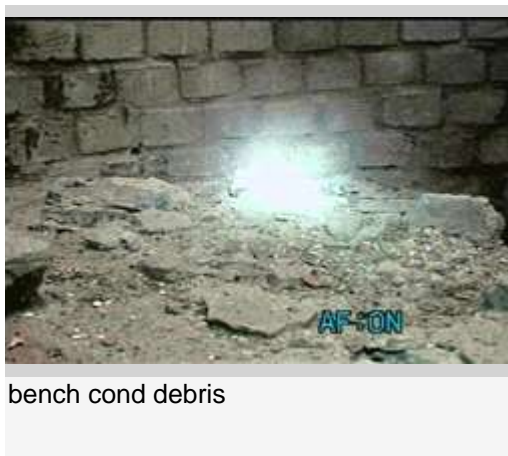
Defect 4

Condition: ☐ Sound ☐ Cracked ☐ Root Intrusion ☐ Deteriorated ☐ Leaks ☒ **Debris**

bench cond debris

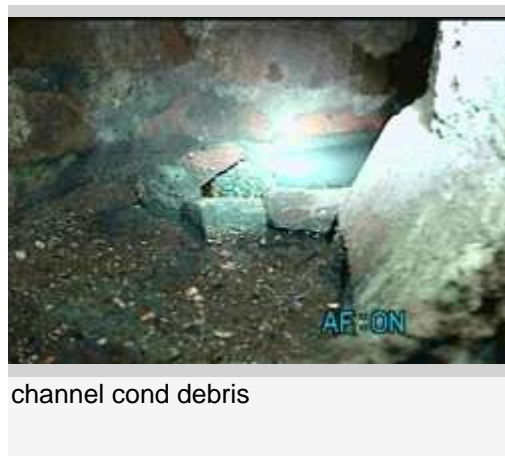
Defect 3

Condition: ☐ Sound ☐ Cracked ☐ Root Intrusion ☐ Deteriorated ☐ Leaks ☒ **Debris**

channel cond debris

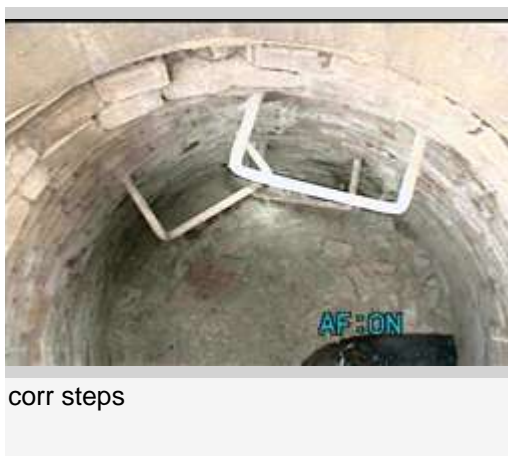
Defect 2

**Steps** Count: **3** Missing: **0** ☒ **Corroded**

corr steps

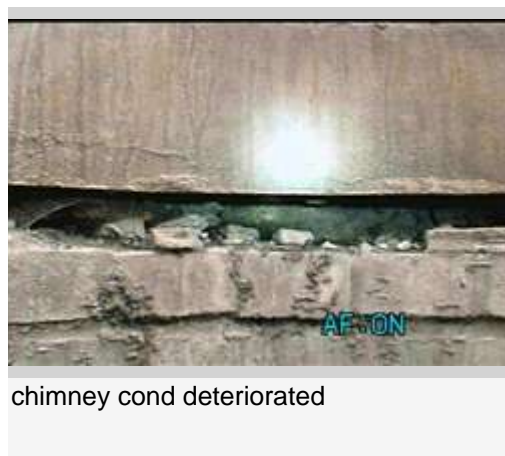
Defect 1

Condition: ☐ Sound ☐ Cracked ☐ Root Intrusion ☐ Loose Brick ☒ **Deteriorated**

chimney cond deteriorated

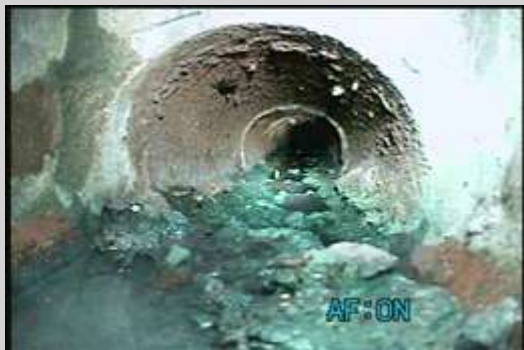
12 O'Clock Outflow

8 in. Circular Gravity Sewer  
Pipe Out @ 12 O'Clock

Deposits: ☐ None ☐ Mud ☒ Sludge ☒ Debris ☐ Grease

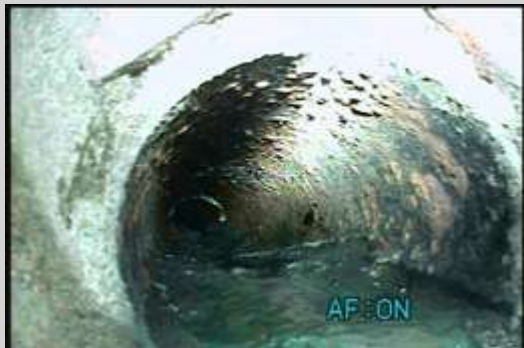
3 O'Clock Inflow

8 in. Circular Gravity Sewer  
Pipe In @ 3 O'Clock

Deposits: ☐ None ☐ Mud ☒ Sludge ☒ Debris ☐ Grease
